Case Study: Improvement of the Maer Lane STW Inlet Works

HUBER Technology recently completed and commissioned a large project for South West Water to improve the inlet works facility at the above site which treats the sewage from the town of Exmouth in Devon.

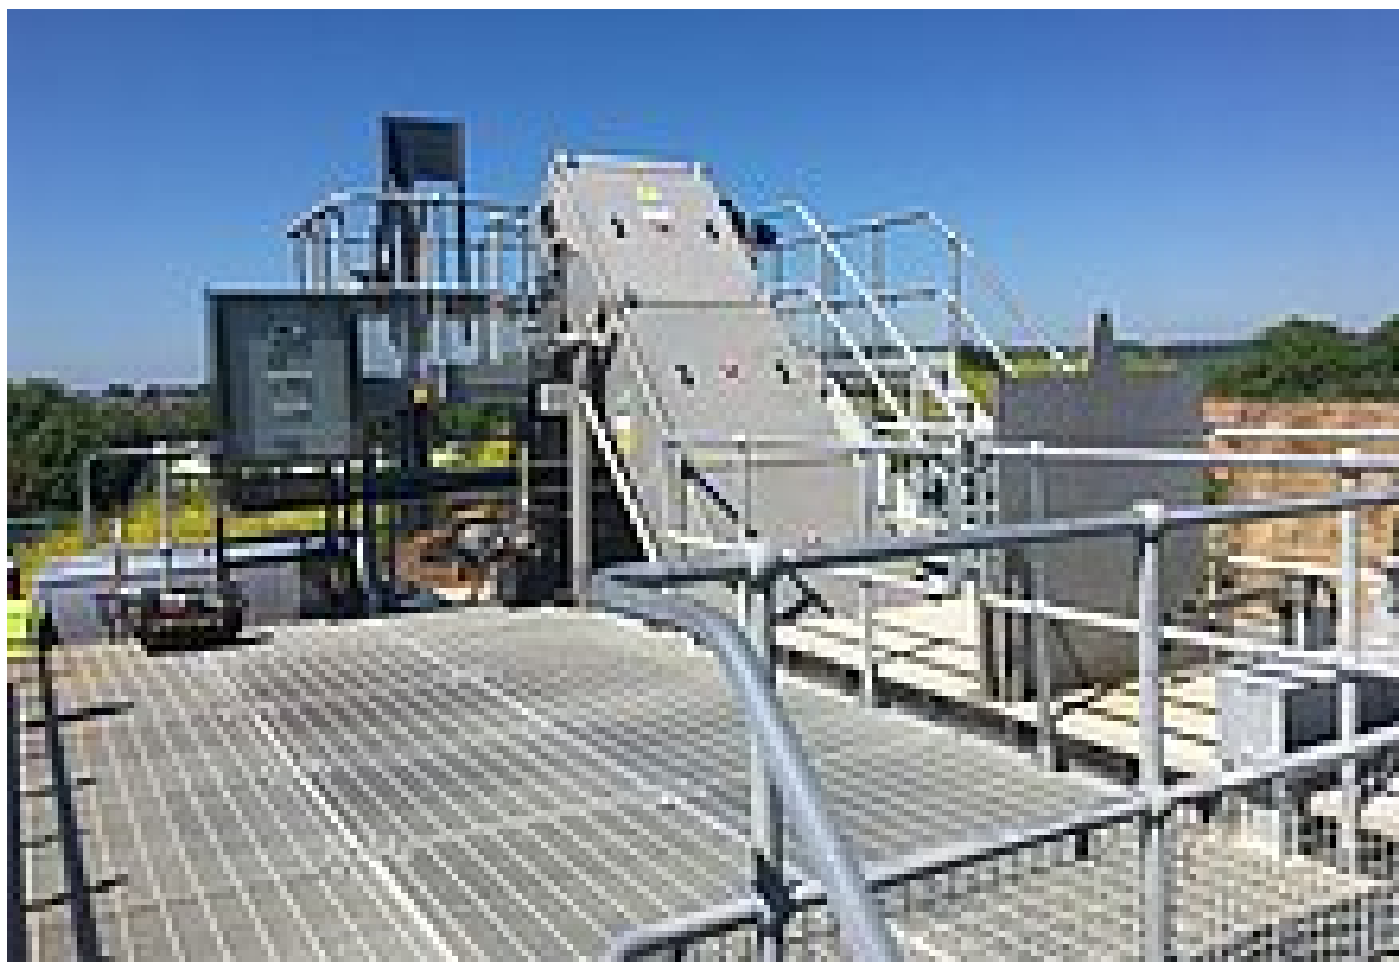
New RakeMax® screen installed on top of the existing balance tank

Previously the flow into the balance tank was via four pumped rising mains, flow to the inlet screens was controlled by penstocks in the balance tank. We worked with the contractors – Tecker to develop a solution to minimise downtime. This solution was to install the coarse screen into a off-site fabricated site channel which could be mounted on top of the existing balance tank structure.

This was installed on site and the rising main connections made, the coarse screen was then installed into it with the screening discharging directly to a skip.

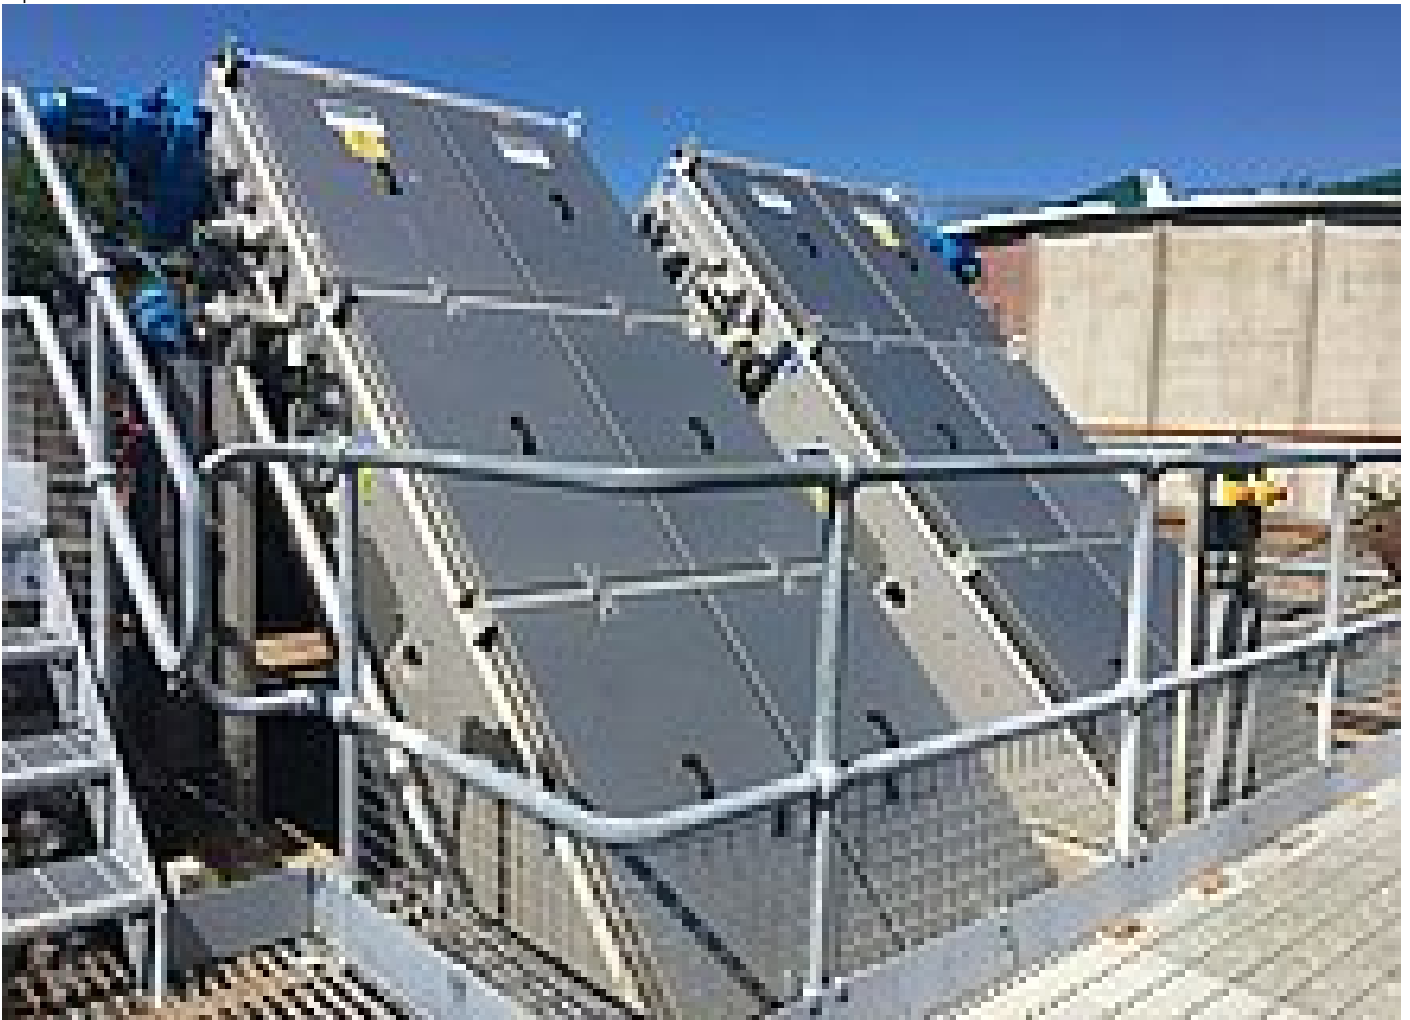
New EscaMax® screens installed at 60 degrees into the existing inlet works

The fine screens and handling plant were installed in a phased manner to allow the screening at the inlet works to be maintained.

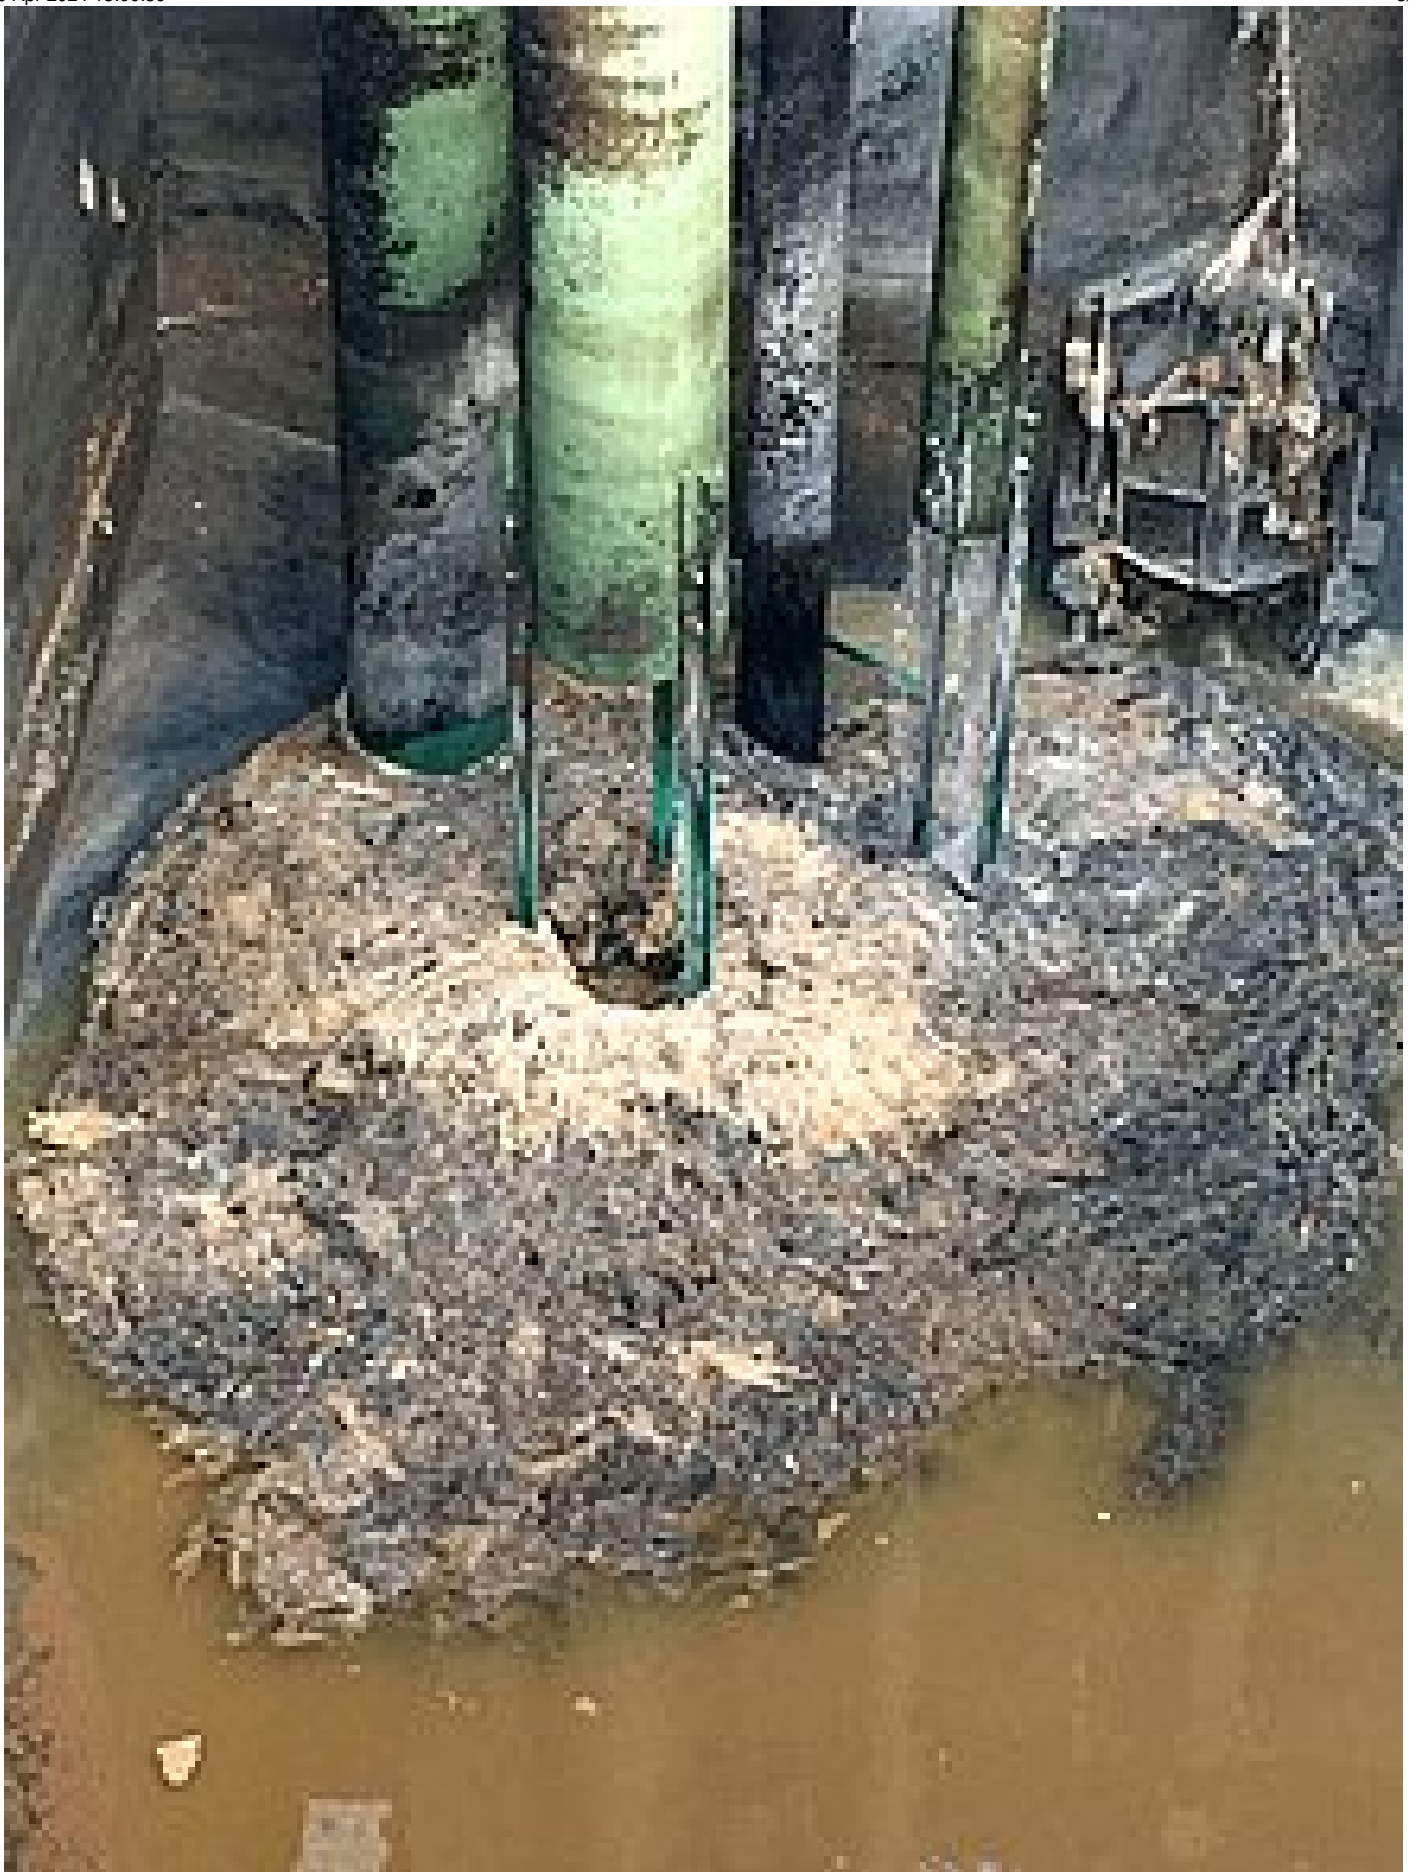
Screenings build up in balance tank – before screens were fitted

HUBER Technology were approached by Tecker towards the end of 2015 to look at improving the existing inlet works on site. The site features a balance tank which was prone to a large build up of rag and screening which were overloading the existing inlet works. Cleaning of this rag build up proved difficult and dangerous so the project was split into two sections, supply of a coarse screen to protect the balance and storm tanks and supply of new fine inlet screens and screenings handling equipment.
